# Crash-Related Motorcycle Helmet Retention System Failures

#### John Lloyd<sup>\*</sup>

BRAINS Inc., San Antonio, Florida, USA

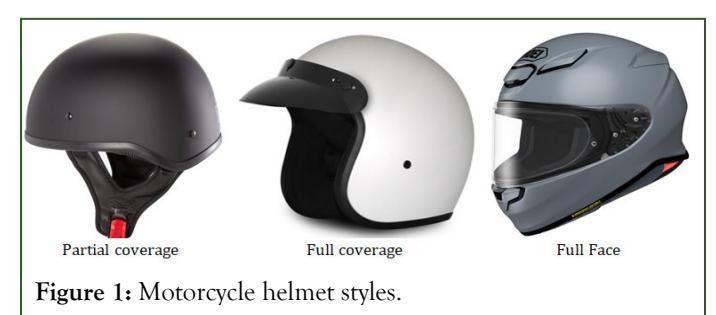
Motorcycle helmets are typically grouped into three categories: partial coverage (aka shorty or half) helmets, which, by design, do not extend over the rider's ears; full coverage (aka threequarter) helmets, which extend over the rider's ears and further down the back of the head, but offer no face protection; and full-face helmets, which are similar to full coverage, but also include a chin bar to afford some protection against facial impacts (Figure 1).

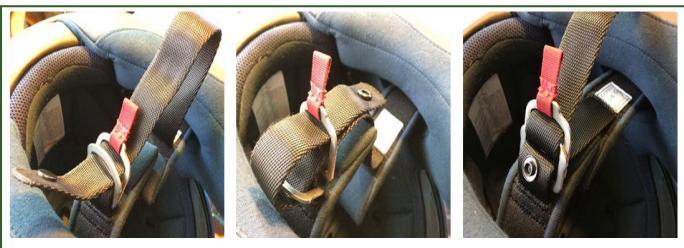
Figure 2: Operation of Double-D ring helmet retention system.

Motorcycle helmets are secured to the rider's head by means of a retention system. The most common retention system utilized on motorcycle helmets involves a strap, originating from one side of the helmet, which is secured to the opposite side using a 'Double-D ring' mechanism. The retention strap is passed through the centers of the two D-rings, then over the outer ring and back through the inner ring (Figure 2). It is well accepted that motorcycle helmets may be ejected from a rider's head during a collision event due to user error, mechanical failure, or design defect.

When tightened the Double-D ring retention system is generally very effective in preventing a helmet from being ejected off the rider's head. The strength of the Double-D ring helmet retention system lies in the friction generated between the retention strap and the D-rings, which is maximized when the D-rings and strap are parallel. The procedure to release this retention system involves lifting the D-rings so they are no longer parallel with the strap, thereby reducing the friction between the strap and Drings, which allows the strap to slide freely.

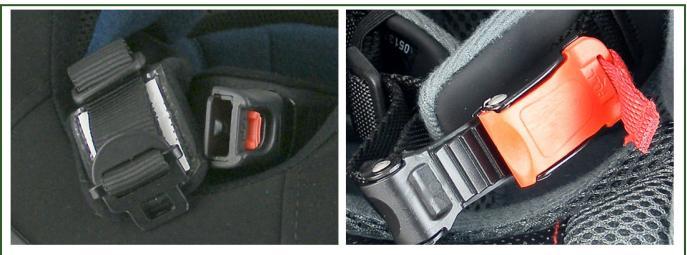
Figure 3: Quick release buckle and micrometric retention systems.

However, operation of the Double-D ring retention system is not intuitive to a novice user, who will require some education on its operation. Without training many new users will fail to secure their helmet, which can lead to inadvertent ejection of the helmet. Such user error was reported as the number one cause of crash-related motorcycle helmet ejections in both the United States Hurt study and European MAIDS study [1,2]. This has given rise to alternative, simpler retention systems, such as quick release buckles and ratcheting (micrometric) fasteners, though mechanical failure rates of these devices tend to be higher, particularly for products with non-metal components (Figure 3).

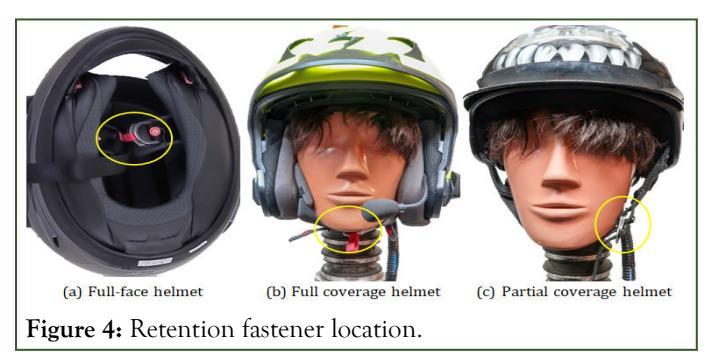
However, further investigation has identified a difference in the fundamental design among partial helmets, full coverage, and full-face helmets. Specifically, the retention system on full-face and full coverage motorcycle helmets fastens under the chin of the rider (Figures 4a and 4b), while partial coverage helmets tend to fasten on the side of the face (Figure 4c).

When fastened, the double-D rings and retention strap on fullface and full coverage motorcycle helmets are near-parallel, thereby maximizing the friction on the strap. The strength of the retention system is thus optimized. Whereas, on many partial coverage helmets, the double-D rings are located on the side of the face, producing an oblique angle between the retention strap and D-rings, which reduces the friction on the retention strap, similar to the orientation required to release the retention system. Hence, during a collision event and in accordance with the laws of physics, the force acting on the retention system of a partial coverage helmet can exceed the friction between the retention strap and D-rings on the side of the face, allowing the strap to loosen and the helmet thereby be ejected from the rider's head.
