Original Paper

STRATEGIES FOR MANGROVE REHABILITATION IN AN ERODED COASTLINE OF SELANGOR, PENINSULAR MALAYSIA

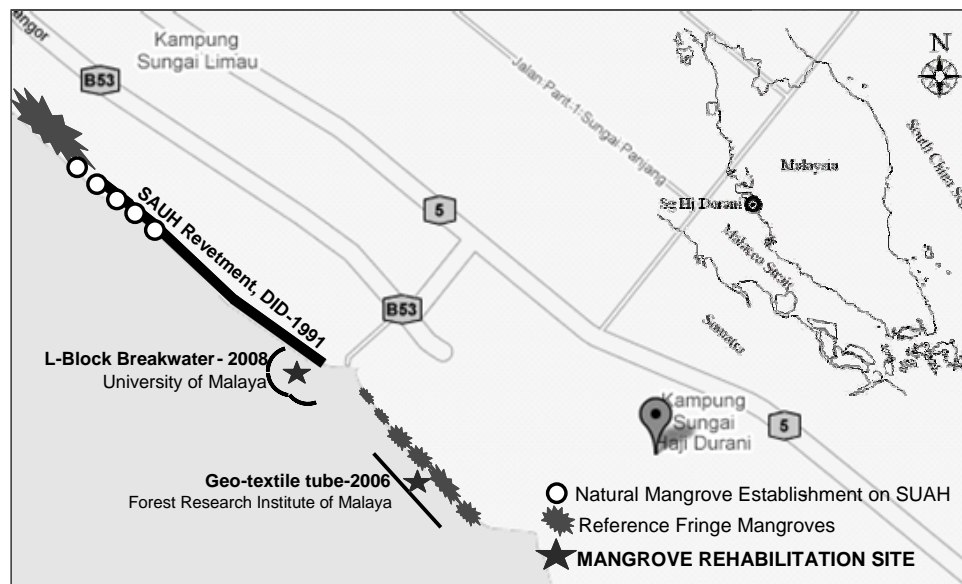
Fig. 1 Map showing the Mangrove Plantation Sites at Sg.Hj.Dorani, Peninsular Malaysia

Sungai Haji Doraini is situated in Sungai Besar a coastal town in the district of *Sabak Bernam* in *Selangor, Malaysia* (Fig 1.). It is

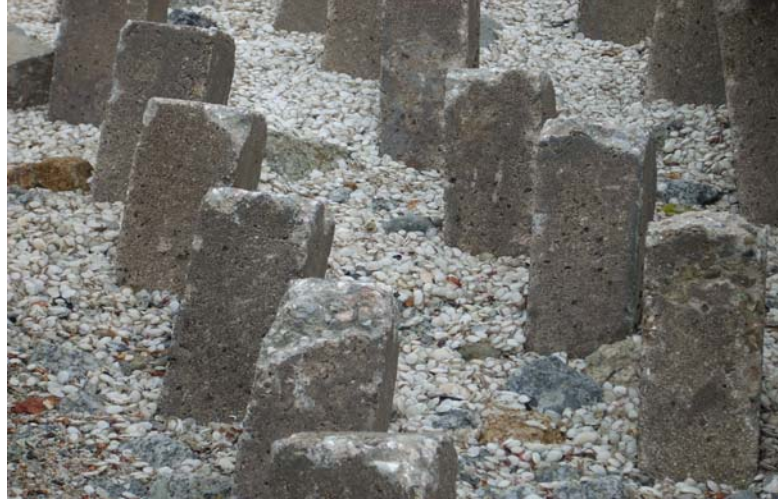
Fig 4. Photograph showing the calcareous deposits on the shore and revetment indicating current erosion and littoral drift

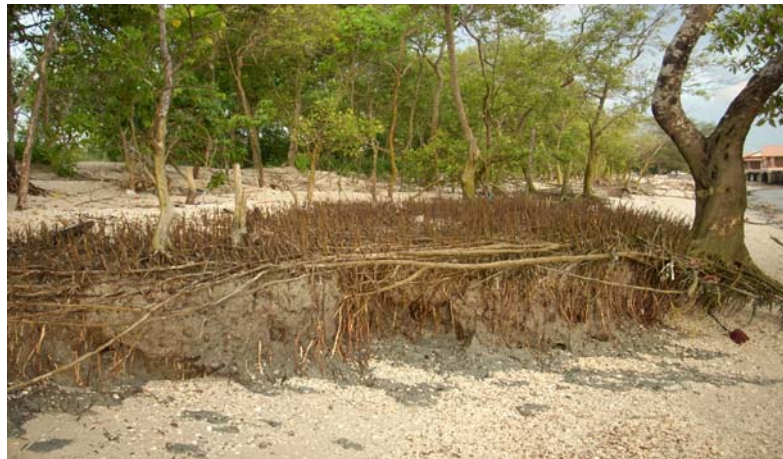
Fig. 5 Photograph showing the effect of coastal erosion on the fringe mangroves – the reference forest patch available to understand the natural vegetation profile is at the verge of extinction

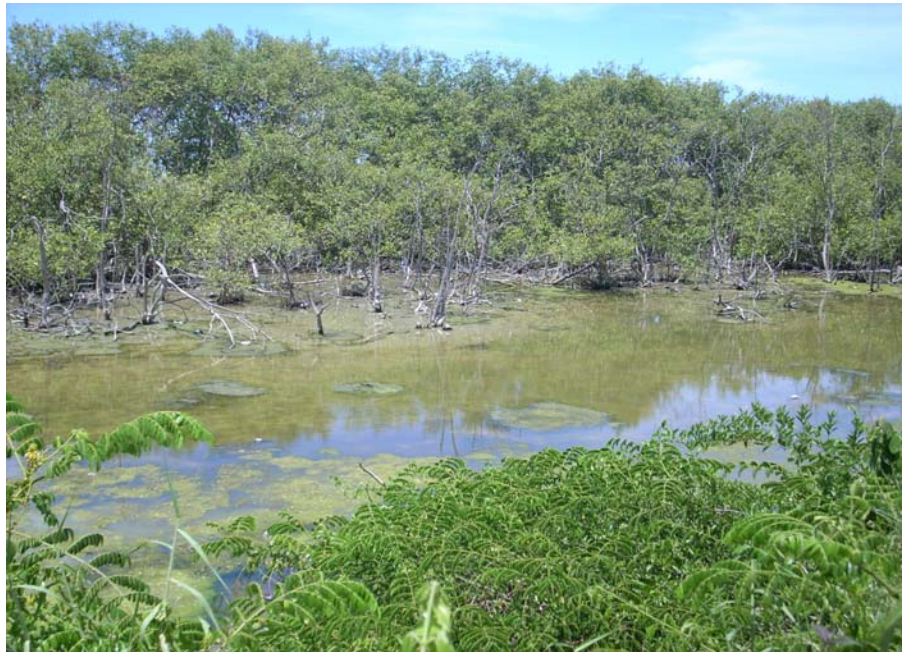
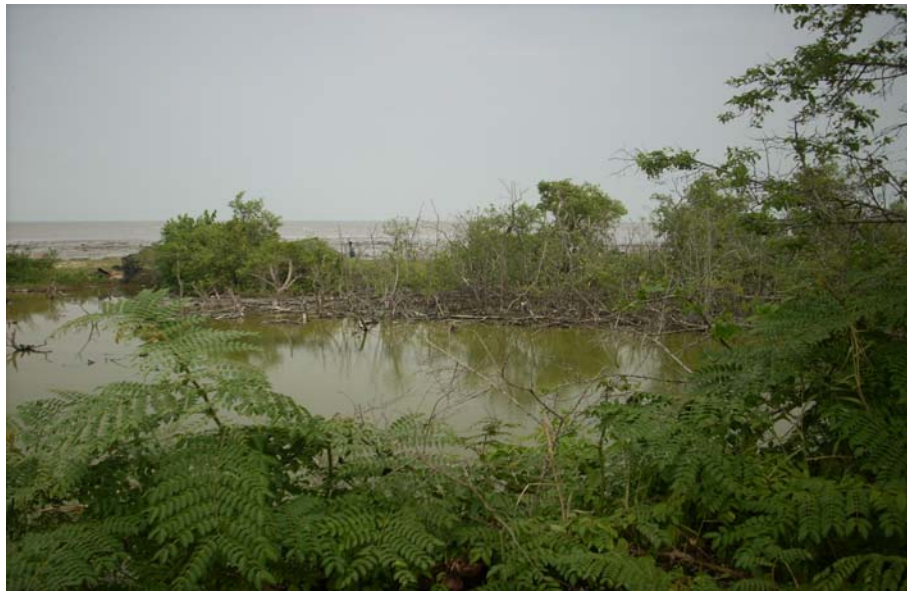
Fig. 6. Photograph showing the water-logging, drying and loss of mangroves in June 2009 in front of FRIM's mangrove plantation site substantiating ignorance to conserve existing mangroves

There is no outlet for the water to drain from mangroves and hence the mangroves are dying. The fate of the existing mangroves, the speed of degradation and ignorance or negligence in conserving the existing natural resource is substantiated in the **Fig. 6 and Fig. 6a**. Unless the hydrology of that area is restored there will not be any mangroves in near future either to protect the shoreline or to provide seeds for future forest establishment. Differential survival and growth of mangrove species studied to date are related to the depth, duration and frequency of flooding and soil .

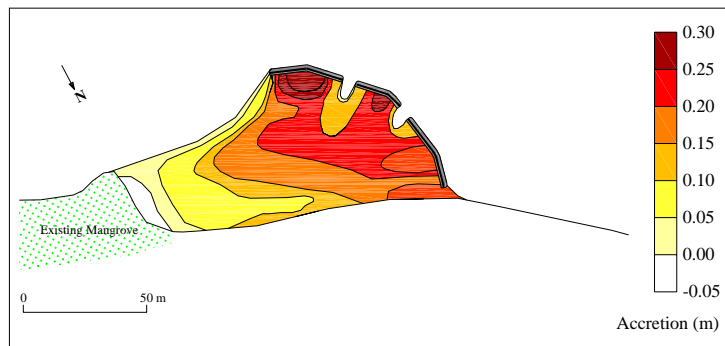
Fig 7. Rate of Sediment accretion at the mangrove plantation site in October 2008, 4th month after construction of L Block Break water

There is a site specific erosion and deposition occurring along the Sg. Hj Dorani coast due to construction of resort and installation of engineering structures like Geo Textile Tubes and L Block Breakwater. After the construction of breakwater in May 2008, the sediment accretion is ± 0.0037 cm per annum which is considerably negligible in dynamic patches (Kamali, Personal communication) in mud flat where plantation is carried out (Fig 7&7a). The presence of the large grain size shell hash along the coast indicates that the shoreline is still experiencing some major wave and current erosion. The area prior to the breakwaters being installed was quite deep and has collected fine grain mud over time with the reduced wave action. Along the coastline curvature in few locations sand deposition is observed towards landward side, which fragments mangroves for a small distance up to 100 to 150m. Damage to the mangroves strongly affects sediment budgets and promotes coastal erosion (Kamaludin and Woodrofee, 1993). The eroded sediments may cause further damage to the mangroves. For example, Young and Harvey (1996) showed that sediment accretion interferes with root aeration in *Avicennia marina* var. *australasica*. Similarly, movements of sand in mangroves habitats on Portuguese Island, Moszambique have caused high mortality of *Ceriops tagal*. This has altered the mangrove species composition and depleted the crustaceans and mollusks from the mangroves (Hatton and Couto, 1992). The proposed plantation site is experiencing sand erosion that is deposited to the sides, but it could be more complicated than that. Certainly, where sand accumulates to the right elevation (east), mangroves colonize. Where it does not accumulate or erodes, the elevation is too low and hence volunteer mangroves do not exist and planting or replanting will not overcome this limitation.

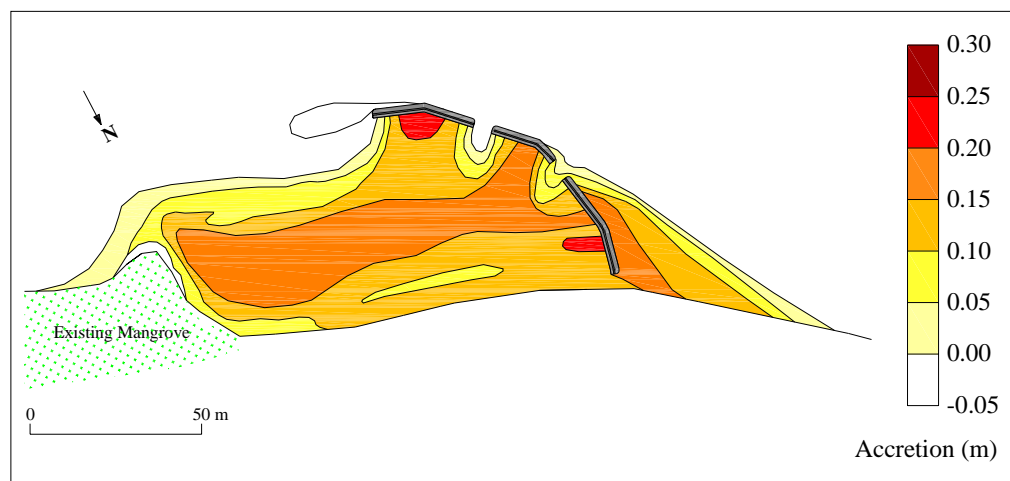
Fig 7.a. Rate of Sediment accretion at the mangrove plantation site in February 2009, 8th month after construction of L Block Break
